Engineering Assessment of Two Cylinders Observed at the Douma Incident**- Executive Summary**

DRAFT FOR INTERNAL REVIEW
Expanded Rev 1 - 27 February 2019

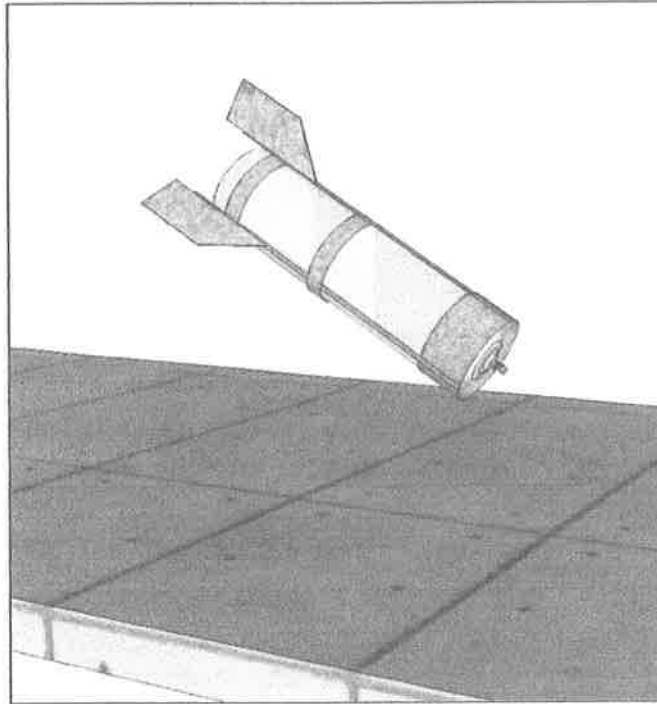
Figure 11: Test case - nose-down angle of incidence
